# THE VIENNA ROOF REGISTER – INVESTIGATING HISTORIC WOODEN ROOF STRUCTURES IN VIENNA’S CITY CENTRE

**ABSTRACT:** The Vienna roof register illustrates the technical development of historic wooden construction on the basis of Vienna’s roof structures. Timber roof frames appear to survive from six centuries in the inner city and are a store of knowledge about choice of materials/sourcing, planning/preparatory measurement, construction type/method of execution and organisation of the building site/erection procedure. The history of the development of roof frames is shaped by experiment and empirical evaluation. Today, the surviving stock can be investigated and evaluated systematically by scientific methods.

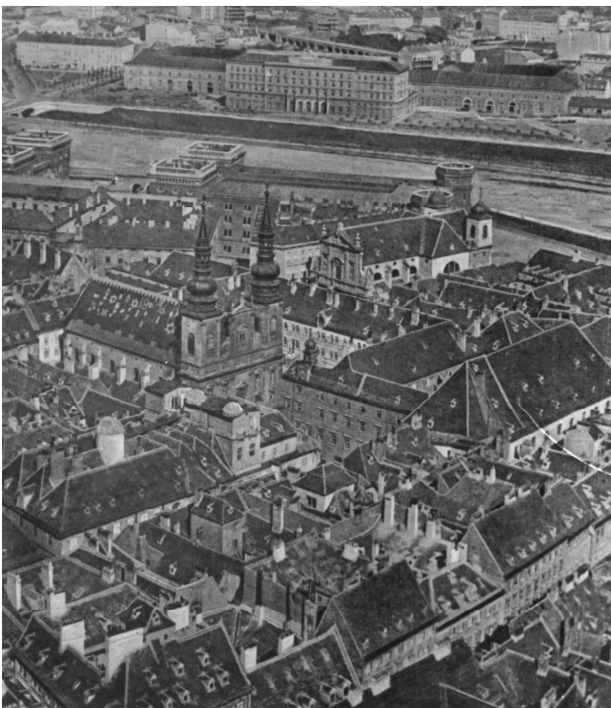
**Figure 1:** Vienna’s roovescape c. 1860. View from St. Stephen’s eastwards towards the Old University (BDA Photo Archive)

The Viennese roovescape conceals a hidden treasure of timber constructions hundreds of years old. The situation has changed a great deal in recent decades, however (Fig. 1, 2). A well-rounded historic texture has mutated into a heterogeneous, technoid-reshaped mixture. The Austrian Federal Monuments Authority (BDA), the

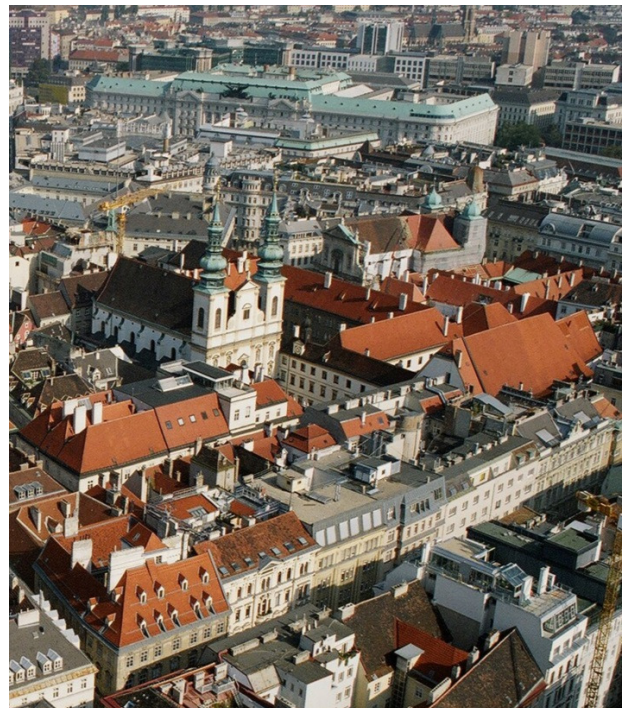
**Figure 2:** The roovescape in 2007. View from St. Stephen’s eastwards towards district around the Old University. In the foreground the façades of Wollzeile, in the centre of the picture the roofs of the old university with the Jesuit Church and in the background the buildings of the Ringstraße zone (BDA Neubauer-Pregl)

although the gables are hipped. The second example is Weihburggasse 16 with a parallel roof, which is in this case side-gabled. Here the two saddleback roofs are connected by a thin passageway, which includes a door enabling the maintenance of the roof dip. Dips parallel to the street also occur in the typically Viennese M-shaped roof (Fig. 10 central column, centre and bottom). M-shaped roofs can occur with a single dip or a pair of dips. The Old University is an example for such a double M-shaped roof with two dips (Fig. 2 on the far left). In most cases these roofs are hipped at the gable end.

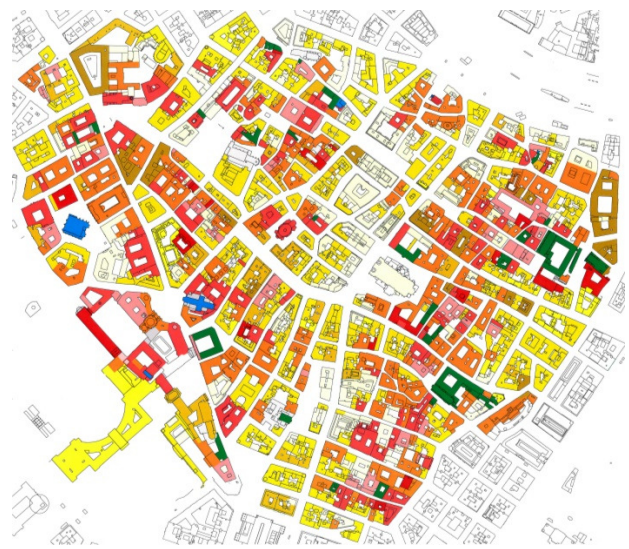
**Figure 4:** Provisional map of the roof structures in the historic city centre with building age (Blue - Gothic; Green - Renaissance; Red - Baroque; Orange - Classicist; Ochre - Gründerzeit; Yellow - 20<sup>th</sup> century)

Vienna's 1<sup>st</sup> District is divided into the Ringstraße zone with roof structures from 1860 onwards and the historic centre in which roofs survive from many different centuries (Fig. 3). The map in Fig. 4 illustrates the number and distribution of building ages found in the historic centre.

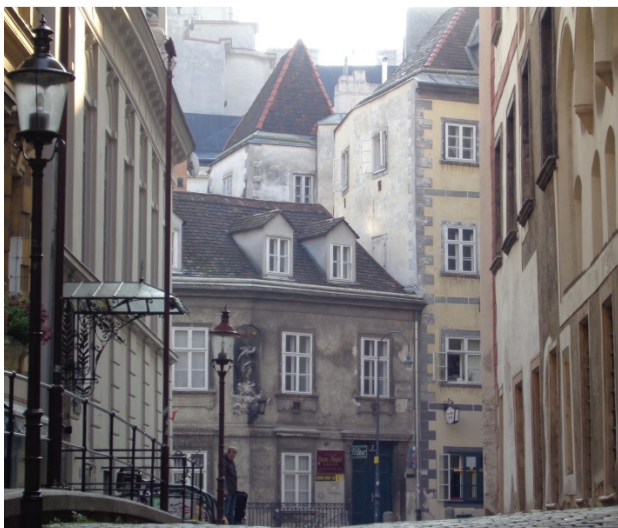
Figure 5: View through Griechengasse of the house complex Fleischmarkt 11, with what appears to be the oldest surviving roof structure in the historic centre, 2015 (BDA Liebich)

The oldest timbers known at the moment are from the roof of the tower of St. Rupert's church and date to 1160 [12]. Their place in the history of the building is unclear at the monument. The oldest roof structures can be found above religious buildings from around 1400 onwards, surviving roofs from secular buildings appear to begin at around 1500 (Fig. 5, 17).

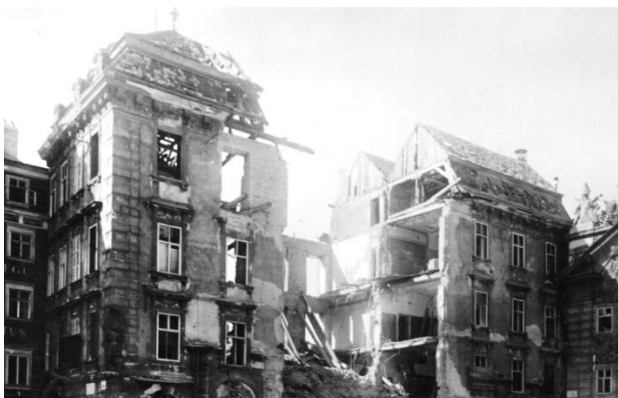
Figure 6: The badly damaged building Am Hof on 19 July 1946 (BDA Photo archive)

The M-shaped mansard roof also belongs to the group of Viennese roofs with dips. In this case a M-shaped roof and a break of slope are combined. This was a type which appears to have been common in Vienna, but which is now only rarely preserved (Fig. 6).

The M-shaped mansard roof, which was already mentioned above, occurs in a few cases in Vienna, which are always side-gabled (Fig. 6). Only one example of a gable-ended roof of this type is known at the moment and it could in fact be an untrussed roof with a break of slope (Fig. 23). In this case, at Schönlaterngasse 6, the two upper rafter roofs are hipped. The history of the building tells us that the roof could date to before 1709 and that it was already subjected to conversion at the

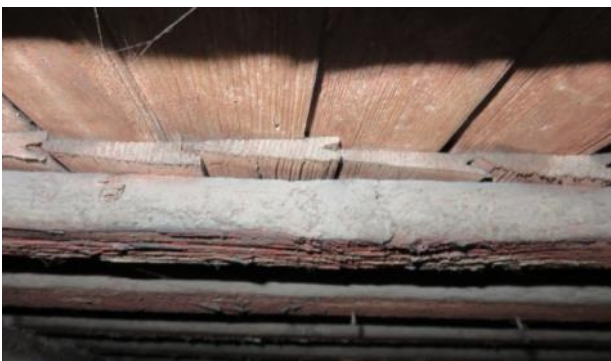
**Figure 8:** Detail of the tongue and groove wooden shingles, which have survived over a large area beneath a recent cement-asbestos covering. Haidgasse 6, 1020 Vienna, 2016 (BDA Liebich)

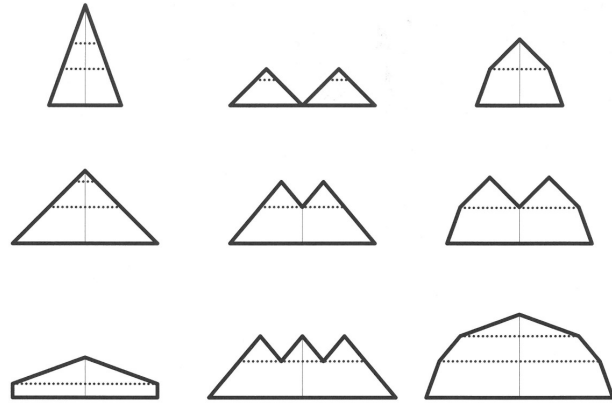
**Figure 10:** Roof forms

*Left-hand column – saddleback roofs*

*Top: steep saddleback roofs, 50-70°*

*Centre: saddleback roofs, 40-50°*

*Bottom: flat saddleback roofs, 20-40°*

*Central column – dip roofs*

*Top: parallel roofs*

*Centre: simple M-shaped roof (Firstgrabendach)*

*Bottom: double M-shaped roof (Doppelfirstgrabendach)*

*Right-hand column – mansard roofs*

*Top: simple mansard roof*

*Centre: M-shaped mansard roof (Firstgrabenmansarddach)*

*Bottom: mansard roof with a triple slope*

The third group, that of mansard roofs, is not very common in Vienna's historic centre. It occurs in its simple form above very small buildings, in which case it was often historically living space. Larger objects often feature a dip in the upper part of the roof, which serves to reduce the interior space and the height of the ridge. Only one example of a mansard roof with a triple slope (Fig. 10 right column, bottom) has been found to date, in the Herrengasse 9.

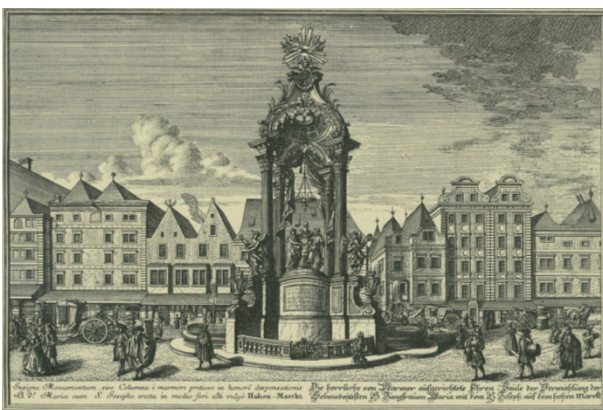
**Figure 12:** House façades at Hoher Markt, engraving 1733, Salomon Kleiner: *Das barocke Wien in Stichen 1700 - 1761*, Reprint 1971

In past centuries the surface of the roof was intensively maintained. Old engravings repeatedly show ladders needed for this constant care (Fig. 12, right-hand side). These surfaces are still exposed to the elements today, but “intelligent” conversion systems aim to prevent damage in future. Ventilation, subsidiary layers, insulation, waterproofing, installations and fire protection material are installed below the skin of the roof. In historic roof structures this complicated series of layers is permeated by numerous constructive timbers and is only very rarely possible without damage at some point. Not only structural concerns but also statics, room height, circulation, wheelchair access, emergency exits, chimney cleaning, lighting and noise reduction all make demands of the substance, so that an up-to-date conversion compatible with conservation ultimately becomes impossible. The monuments service aims to hand on authentic roof structures to future generations. This involving upholding the exterior appearance of the object, preservation of the greater part of the roof structure in situ and of its living presence in the attic area, and also its actual purpose as a loadbearing construction.
